SHORE EROSION STUDY

SHORELINE EROSION AND BLUFF STABILITY ALONG LAKE MICHIGAN

AND LAKE SUPERIOR SHORELINES OF WISCONSIN

KENOSHA COUNTY

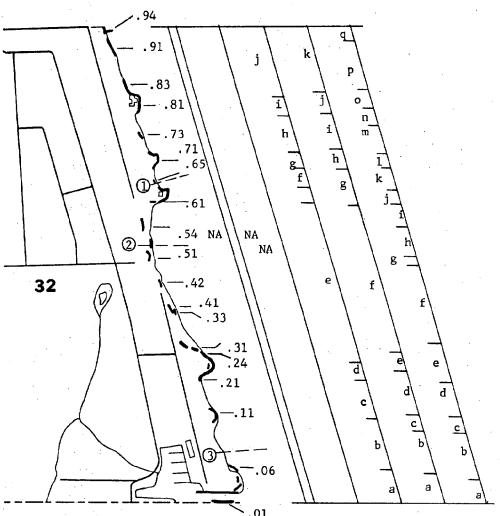
1. BLUFF	å-structures	b-slumping and wave erosion, scalloped bluff edge	c-slump; scalloped bluff edge	d-structures
	e-slumping and wave erosion along entire stretch, scalloped bluff edge with visible slump blocks	f-structures	g-slump scalloped bluff edge sand, also wave erosion of the toe	h-stable; structures
	i-slump, wave erosion of toe	j-some erosion, but protected by structures, some slump	k-bluff is beach sand, failing by slump and wave erosion of toe, scalloped bluff edge	*entire bluff in this section is beach sand (very fine to coarse) anywhere protection is absent, there is slump and wave erosion of toe sand taking place

2. TOE	a-concealed	b-beach sand	c-concealed	d-beach sand
	e-concealed	f-beach sand	g-concealed	h-concealed
	i-beach sand	j-concealed	k-beach sand	*all toe materials are in place, very fine to medium beach sand except where con- cealed by structures

3. BEACH	a-no beach	b-20 to 40 ft. sand and gravel	c-no beach	d-30 to 50 ft. sand, some gravel
	e-no beach	f-beach widens steadily 15ft. at north,110 ft. at south of segment, sand and some grave1	g-no beach	h-20 to 30 ft. sand and gravel
	i-60 to 90 ft. sand and gravel	j-no beach	k-20 to 40 ft. sand and gravel	l-no beach
	m-20 to 40 ft. sand and gravel	n-100 ft. sand	o-no beach	p-10 to 100 ft. sand and gravel widens southward
	q-0 to 5 ft.	el .

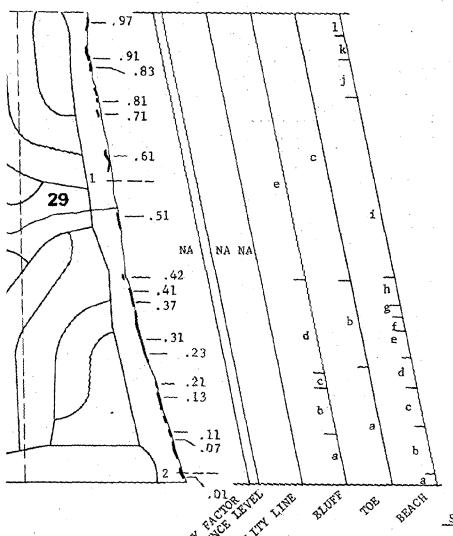
1. BLUFF	a-beach sand, eroding by slump and wave action.	b-beach sand protected by structures	c-beach sand slumping	<pre>d-fairly stable bluff is beach sand protected by structures</pre>
	beach sand -s through wave	and is slumping erosion-swallows holes laterally	in most areas and also weaken blu	, all composed of d also being lost ff by boring ests. Sand is very
2. TOE	a-beach sand	b- beach sand; mostly con- cealed by structures	c-beach sand	
3. веасн	a-less than 5 ft. gravel	b-10 to 20 ft. sand and gravel	c-no beach	d-20 to 35 ft. sand and gravel
	e-20 ft. sand and gravel	f-no beach	g-65 ft. sand and some pebbles	h-no beach
	i-40 to 100 ft. sand and some cobbles	j-40 ft. sand and cobbles	k-no beach; structures present	1-25 to 30 ft. sand and gravel

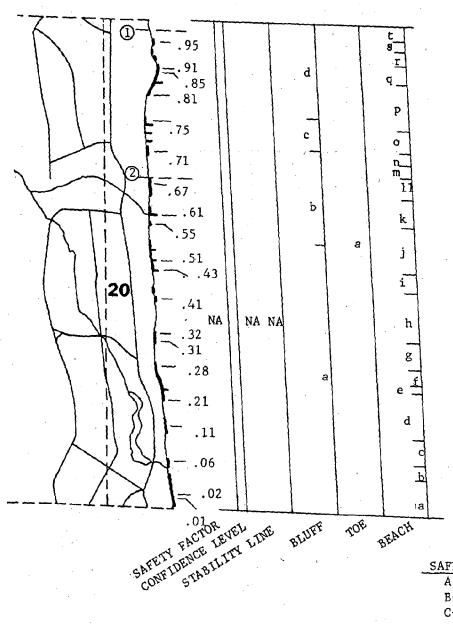
1. BLUFF	a-generally sand, 4 to5 ft. high, failure by slumping and wave erosion where not protected by structures	b-area of slumping and sloughing, bluff edge is scalloped from slumps caused by wave erosion of toe	c-groin field, bluff is fairly stable and vegetated sand	d-sand, 5 ft. high failure by slump; scalloped edge where not protected by structures

2. TOE		is sand, generall xcept where conce		
3. BEACH	a-no béach	b-30 to 40 ft. sand and cobbles	c-5 to 10 ft. sand and some gravel	d-no beach
	e-less than 5 ft. sand	f-no beach	g-10 ft. sand and gravel	h-15 ft, sand and gravel
	i-10 to 15 ft. sand	j-no beach all structures some small beach areas of less than 5 ft.	k-50 ft sand, some pebbles	1-no beach
	m-20 ft. sand and gravel	n-less than 5 ft. sand	o-50 to 75 ft. sand; some gravel	p-20 to 25 ft. sand and gravel
	q-no beach	r-5 to 10 ft. sand and gravel	s-no beach	t-10 to 15 ft. sand and gravel

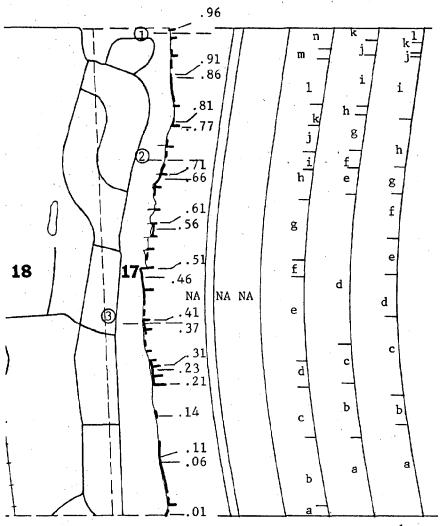
to a strange	we be also a control of the control			
1. BLUFF	a-minor slumping; sand	b-fairly stable protected with structures, well vegetated	bluff edge	d-fairly stable
	e-scalloped bluff edge slumping sand seep zones in lower part of profile 3	f-slumping sand	g-bluff fairly stable;long beaches fairly well vegetated	h-mostly concealed some sand visible, fairly stable with structures
	i-sand;slumping	j-concealed	k-sand,slumping scalloped bluff edge	l-concealed with dolomite structures
	m-sand, scalloped bluff edge; slumps	n-sand+ 20 ft. slumping

2. TOE	a-concealed by vegetation and structures	b-sand, slumping or in place, fine to medium bedded beach sand	c-concealed, lawns, struc- tures	d-sand, fine to coarse layered, beach,slumped or in place
	e-concealed	f-sand, layered, beach	g-concealed, structures, vegetation and fill	h-sand
	i-concealed; structures, some fill	j-concealed, sand	k-sand,slump or in place

3. BEACH	a-no beach	b-15 to 20 ft. sand and gravel	c-20 to 30 ft. sand;some gravel	d-5 to 10 ft. sand and gravel
	e-25 to 35 ft. sand and gravel	f-less than 40 ft. sand and gravel	g-no beach	h-less than 30 ft. sand and gravel, narrows toward south to 10 ft.
	i-no beach	j-40 ft. sand and gravel	k-no beach	1-40 to 50 ft. primarily sand; some gravel

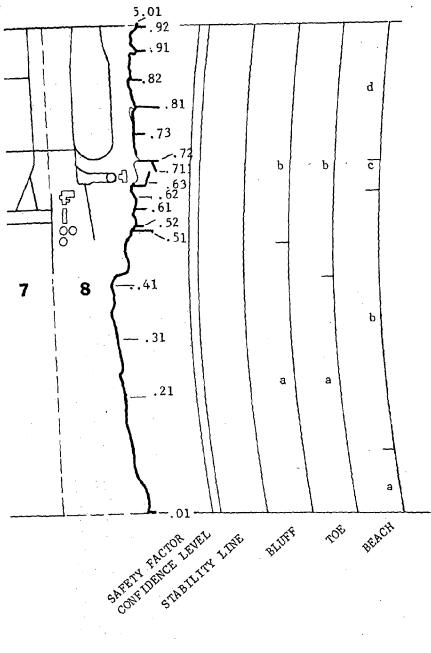
1. BLUFF	a-area concealed by vegetation and revetment which are equal in height to the bluff, bluff height approximately 10 ft.		b-same conditions as in a-, sand dunes		
2. TOE	a-bedded dune and beach sands		b-concealed, toe covered by revetment total length of section		
3. BEACH	a-sand and some gravel accre- tion due to groin on point at beginning of section 17	b-no beach, new revetment(.31 all along her) sand	100 ft.	d-essentially no beach; few areas between groins have some accumu- lation of sand and cobbles, but less than 5 ft.

4. PROFILES-none; the shoreline is concealed with protective structures throughout the entire section.

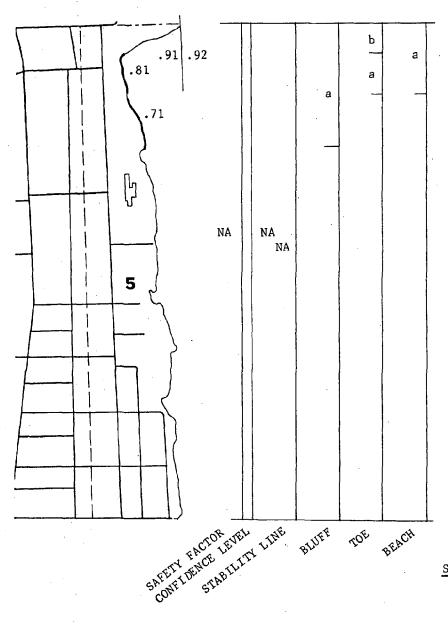
1. BLUFF a-graded no bluff present

2. TOE a-sand b-artificial fill (in back of beach)

3. BEACH a-63-83 ft. sand, beach widens westward from 63-83 ft.

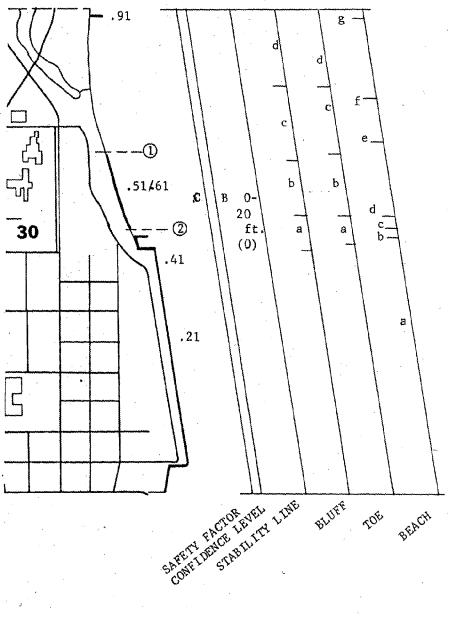
b-this area d-no bluff, c-16 ft. 1. PLUFF a- 5-10 ft. has graded gradual maximum sand and gradual height of slope; appears to slopes; no bluff in maximum be stabilized bluff. this height -maximum segment, about 4-5 ft. height 2 ft. mostly about 10 ft. sand, stable

2: TOE a-sand, gravel b-no bluff c-sand, some d-no bluff and some silt artificial interbedded fill, mostly sand

3. BEACH a-no beach b-72 ft. c-85 ft. d-170 ft. e-125 ft. south, sand and sand and beach gravel gravel gravel narrows to Oft.

f-215 ft. g-275 ft. sand and gravel gravel

^{*}fragments and slabs of precast concrete scattered about on upper part of beach represent remains of old groins. Some slabs now being used as bases for picnic grills, however they are not in original position.

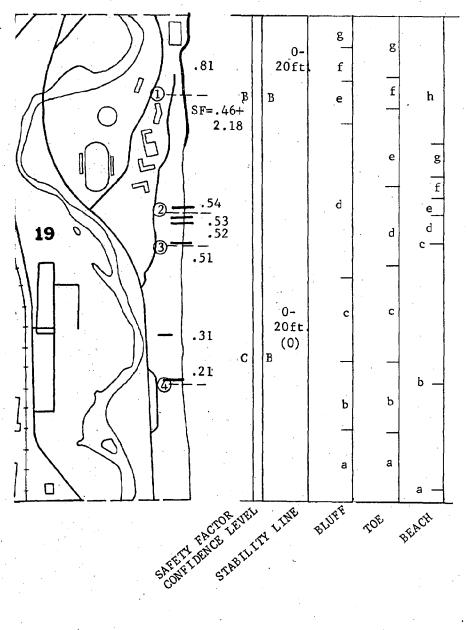
1.BLUFF	<pre>a-no bluff gentle slope upward</pre>	b-grassed; reasonably stable	c-no bluff	d-stable; well vegetated, materials concealed	e-slump area,bluff partially graded
	f-relatively stable in most places; vegetated, bluff partially graded	g-no bluff; graded slope for building			
2. TOE	a-no bluff	b-sand	c-no bluff	d-sand and coarse silt	e-mostly covered
	f-pinkish brown lacustrine clay	g-concealed			
3. BEACH	a-275 ft. sand and some gravel	b-188 ft. sand, some gravel	c-194 ft. sand, some grave	d-151 ft. sand and gravel	e-140 ft. sand and some gravel
	f-110 ft. sand and some gravel	g-20-100 ft. sand and gravel	h-no beach; beach concealed by new dolomite revetment now under construction	·

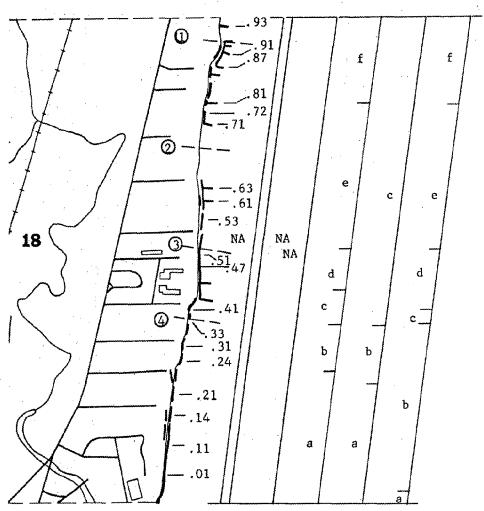
1.BLUFF	a-scalloped bluff edge, lacustrine silt-many places concealed with fill and debris,slump blocks along here in many places	b-mostly con- cealed, some slump areas in lacustrine silts	c-slumping in lacus- trine silts	d-fairly stable grassed area
	e-scalloped bluff edge bluff here 25- 30 ft. high- planar and rotational slump blocks in lacustrine silts	d-lacustrine silts with sand on top (2 ft.), slumping- scalloped bluff edge		
2. TOE	a-either con- cealed or lacustrine sediments in place or slumped	b-concealed	c-lacustrine silts mostly in place some slumped	
3. BEACH	a-less than 5 ft., cobbles	b-no bea c h	c-10 to 15 ft. sand and gravel	d-no beach
	e-less than 20 ft.,sand and gravel less than 40 ft. in places and 25 to 30 ft. in others.	f-0 to 5 ft. sand and gravel mostly gravel and cobbles toward south end of area

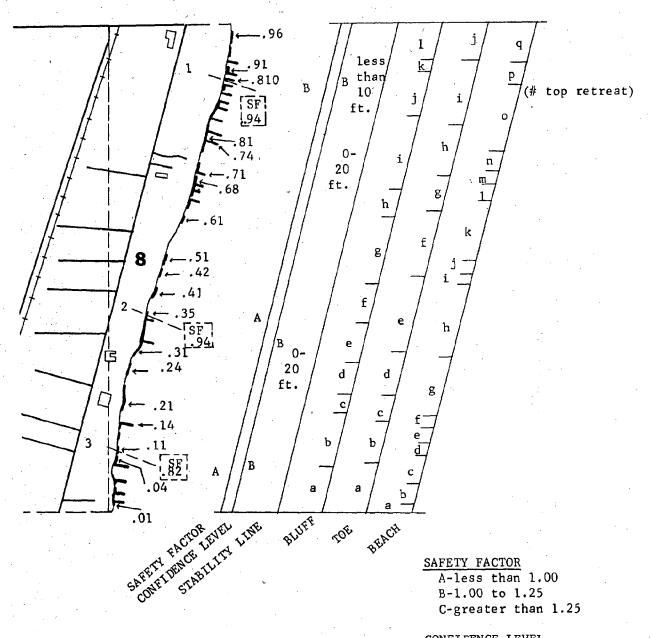
1	,	
1. BLUFF	<pre>a-concealed fill piled on slopes</pre>	b-some toe erosion, but considerable vegetation- much fill	c-fill; slumped	d-till at toe bluff failing by slump and toe erosion	concrete, debris, some
	f-slumping; lacustrine sediments, planar slump,sand at top of bluff	g-fairly stable; vegetated	h-planar slump- previously graded	<pre>i-graded; eroding from runoff</pre>	j-lacustrine silt and clay slump area, blutt scalloped, seep zones in silt
	k-lacustrine silts with seep zones; bluff scalloped, slumps	<pre>l-bluff slumpi in places; dangerous materials piled on slope</pre>	ng

3. BEACH	a-10-15 ft. sand and gravel	b- 5-10 ft. sand and gravel	c20 ft. sand and gravel	d-5-10 ft. sand and gravel	e5 ft. sand and gravel
	f20 ft. sand and gravel	g-no beach	h20 ft. sand and gravel, some small areas -10 ft.	i-5-10 ft. sand and gravel	j20 ft. sand and gravel
,	k-5-10 ft. sand and gravel	l20 ft. sand and gravel	m-no beach	n20 ft. sand and gravel	o- no beach
	p- +20 ft. sand and gravel	q- no beach

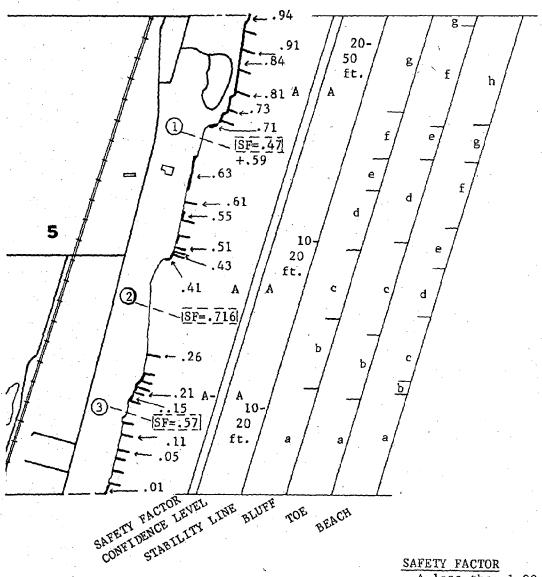
1. BLUFF b-fairly d-slope piled e-graded bluff a-severe c-severe rotational stable; with debris; rotational and planar vegetated, slump, wave failing by slump- toe lawns, etc. erosion s1ump erosion (waves) and slides and flows, scalloped bluff edge f-moderate g-relatively stable, to severe planar vegetated slump and terraced 2. TOE b-unobservable; c-till, in d-mostly a-till e-till overlain by lawns, etc. place, some unobservable; lacustrine slump also where visible, toe sediment, is till some slump, some in place f-unobservable; g-till, in stuctures place and graded lawns 3. BEACH a- -5 ft. b-0-5 ft. c-20-40 ft. d-15-20 ft. e-5-15 ft. sand and sand and sand and cobbles and gravel gravel gravel gravel gravel g-10-15 ft. h-no beach f- -5 ft. pebbles cobbles, and gravel gravel, mostly no

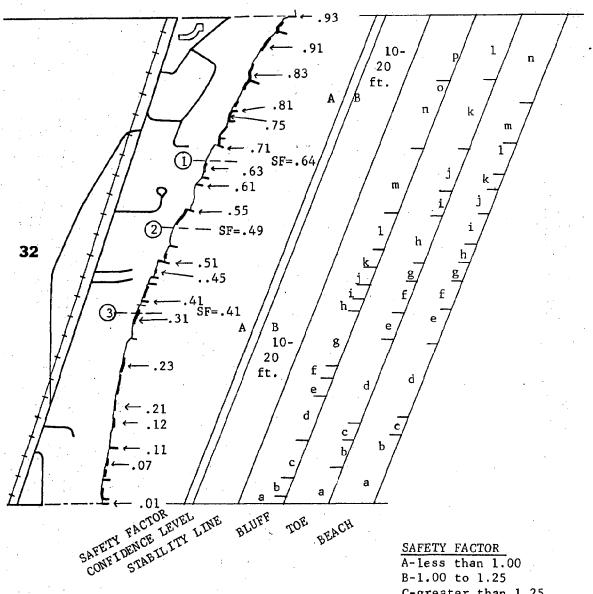
,			1., K. 23E., 3eC. 32
1. BLUFF	a-slump, rotational and planar	b-stable, graded, terraced	c-stable, vegetated	d-large slump block (planar) scalloped bluff edge
	e-rubbish strewn on slope, dangerous	f-graded, stable with large seawall	g-severe slump (planar),also by debris fall	h-severe erosion by slump,seeps in lacustrine silts,sand, scalloped bluff edge
	i-seeps, failure by slide and flow,till, scalloped bluff edge	j-stable, small old slumps	k-filled	1-filled
	m-stable vegetated	n-till and lacustrine soils at very top, some sand and gravel, scalloped bluff,slump, slides and flow tongues	o-failing here, slump slides	p-till, filled concrete, earth, bricks, debris, some unobservable spring midway up slope

2. TOE	a-till or slump	b-graded, concealed	c-till and slump (sand)	d-till,slumped lacustrine sediments or till
	e-till or slump i-concealed	f-till, slump j-till	g-concealed k-till	h-fill,debris l-mostly fill, some till visible

3. BEACH	a-no beach	b-greater than 20 ft. gravel f-less than	c-5 to 10 ft. sand and gravel g-greater than	d-less than 5 ft.,sand and gravel h-10 to 15 ft.,
	m-10 to 15 ft., sand and grave1 i-no beach	j-greater than 20 ft.,sand and gravel n-no beach	g-greater than 20 ft.,sand and gravel k-20 ft.,sand and gravel	sand and gravel 1-0 to 15 ft., sand and gravel

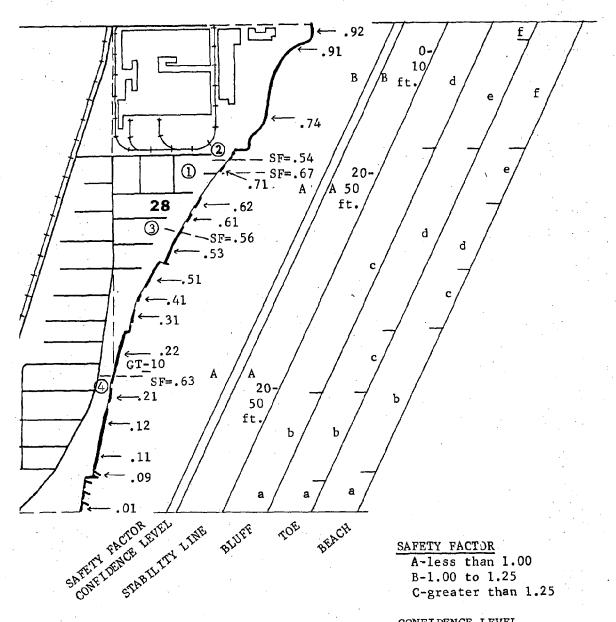
1. BLUFF	a-failure by slump	b-bluff consists of recent artificial fill	c-serious slope failure caused by slump, debris flow; also by the erosion, surface water coming over top of bluff, water issuing from seep zones in silt and sands above till. Foundations undercut and exposed. Scalloped bluff margin, slump scarps at top of bluff.

2. TOE	a-natural toe material is till, covered in most places by slump or artificial fill debris.	b-toe material consists mostly of artificial fill and debris dumped over top of bluff (broken concrete,slag, iron,bicycles, kitchen sinks)	c-dolomite blocks (revetment), with till behind	d-natural toe material is clayey till, till covered in many places by slag (at northern end), broken concrete, dolomite blocks and various types of debris
	e-dolomite blocks (revetment)	f-sheet-steel piling (bulkhead)

3. BEACH	a-0 to 5 ft., cobbles and pebbles	b-5 to 10 ft., pebbles and cobbles	c-no beach	d-0 to 8 ft., gravel,broken concrete, stone, wood, junk
	e-5 to 10 ft., beach is gravel,slag, bricks,junk and iron	f-no beach less than 5 ft.,slag, pebbles, junk	1
